Cortina Systems® LXT973 10/100 Mbps Dual-Port Fast Ethernet PHY Transceiver

Specification Update

20 March 2007

Document Number 249737

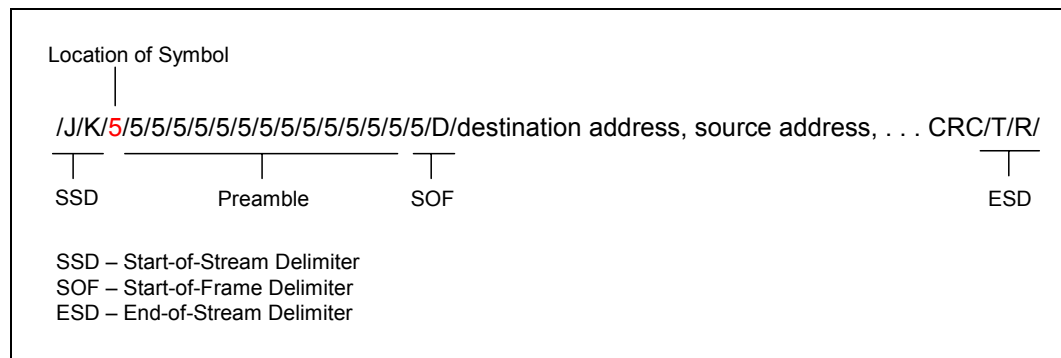
Standard Frame Contents:

Problem An illegal symbol placed immediately after the Start-of-Stream Delimiter (SSD) (preamble after JK) is not detected. However, any subsequent corrupt symbol will be detected.

Implication RXER will not assert if this symbol location is corrupted. However, an error in this location does not affect packet integrity.

Workaround Use the MAC layer protocol to detect corrupt symbols in the packet.
